POINT RICHARDS BOAT RAMP

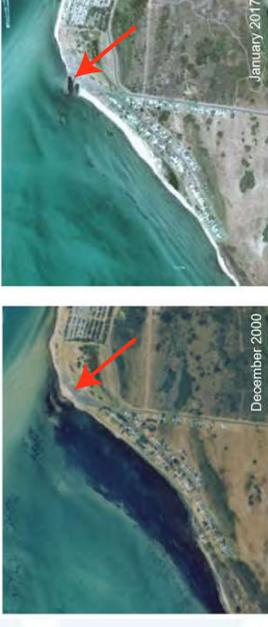
Figure 1: Existing situation Point Richards Seagrass Meadow

- Seagrass detach from the Point Richard Meadow
- The Meadow is currently growing and fluctuates with dry and wet climatic conditions (Figure 1)
- Alongshore ebb currents trap seagrass at the boat ramp
- Weak flood currents cannot flush seagrass out
- A sandbar gradually moves between breakwater heads
- This sandbar can only be dredged with specialist equipment

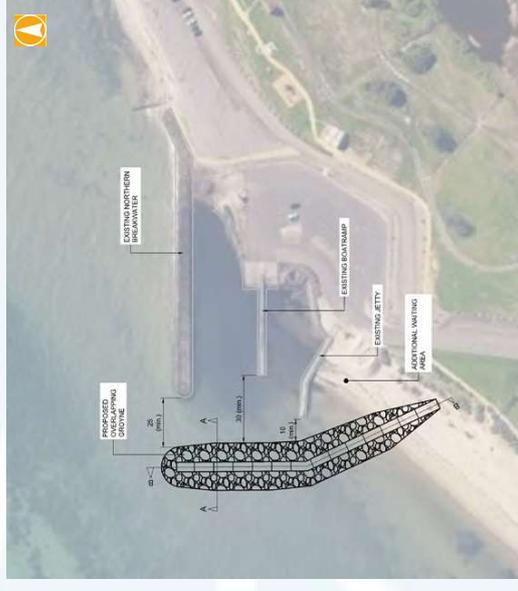
Figure 2: Proposed Breakwater Concept - Plan View

Three possible breakwater configurations were modelled and studied to reduce the accumulation of wrack near the ramp. The most effective configuration reducing seagrass ingress at the boat ramp consists of a deflector to the west of the existing boat ramp (Figure 2 and Figure 3).

Drifting seagrass leaves are deflected into Port Phillip Bay. Alongshore sand is trapped west of the boat ramp. Natural sedimentation will continue across the entrance; however, the deflector provides a convenient access for maintenance dredging of this sandbar. No new impact will come to Portarlington beaches from sand drifting or seagrass accumulation.

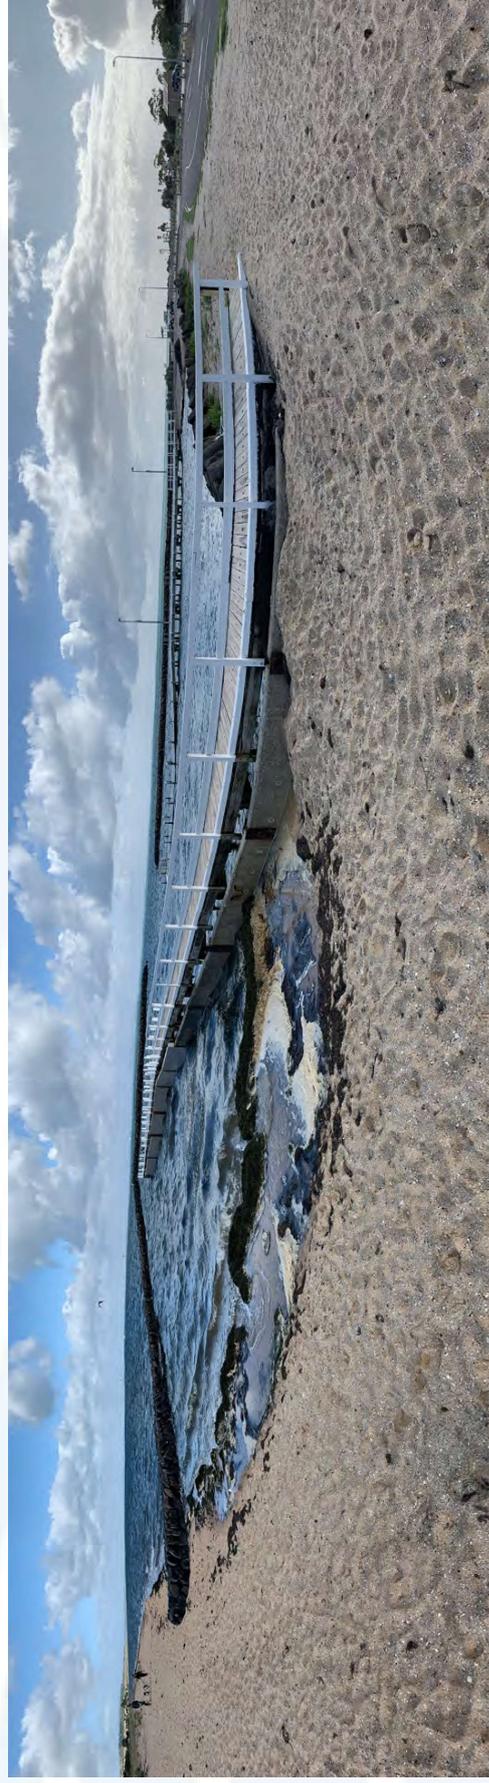
Figure 3: Proposed Breakwater Concept - artist impression
